Hilti PROFIS PS 1000 Report

Project name:	Prj00001	Customer:	Jordan
Location:	Hurricane, UT	Object:	Kitchen floor in a single family home.
User:	Kevin D.Wiederhold		
Comment:	When used welded wire reinforcement is required to be placed in the upper one-third of the concrete slab to be structurally significant. This survey found the reinforcement located in between the concrete and the soil were it does not make any contribution to the durability or resilience of the concrete and it is not functioning as it was intended.

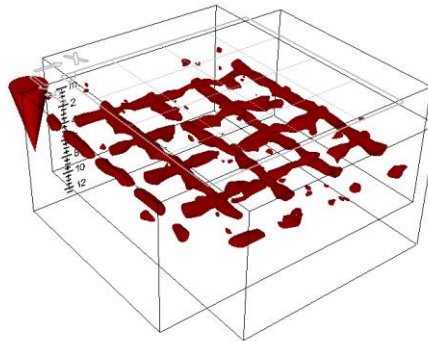
Scan File: RS_158120001_000033.hscan
Scan Name: RS_158120001_000033
Date / Time: 2015-07-07 12:33:23
Comment: 4"x4" wire mesh reinforcement improperly placed at the bottom of a linoleum covered concrete slab
